This step-by-step illustration demonstrates the benefits of our environmentally friendly Rust Primer ARP 662 SG. ARP 662 SG has many applications in marine, automotive, and household areas.

In this photo series the liftgate bumper of a truck is restored with ARP 662 SG.

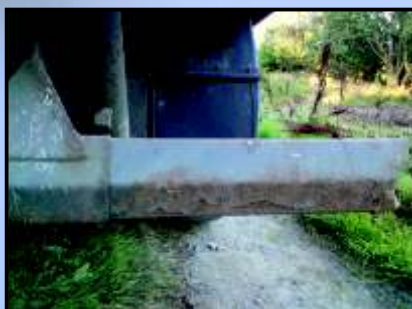
Here is a photo of the untreated bumper of the truck before starting any application of our primer.

Mechanical grinding is an effective measure to take away major rust spots. In general, pressure washing at 140 - 160 bar is enough to prepare the surface; steam cleaning with hot water at around 80° C/176° F is also very effective and can be done simultaneously with a hot water pressure cleaning.

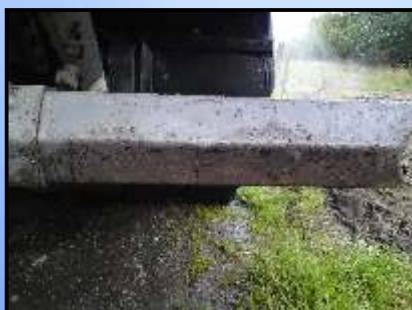
This photo shows the pre-treated bumper.

The bumper has been prepared by wire brushing and hydro cleaning with fresh water. Even on a rainy day, ARP 662 SG can be applied directly over the remaining water droplets on the surface.
